CENTURY MINE MITIGATION STREAM MITIGATION PHOTOGRAPHS
Long Run

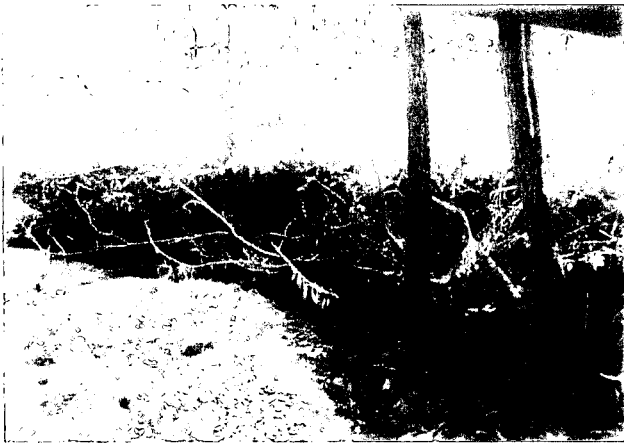
Photograph: 80
LRR-10: Eroded bank in area of coir log installation
